PIKE TOWNSHIP
MUNICIPAL AUTHORITY
DAM

NDS I. D. No. PA-00916
PENNDER I. D. No. 17-111

PHASE I INSPECTION REPORT
NATIONAL DAM INSPECTION PROGRAM

PREPARED BY
GAI CONSULTANTS, INC.
570 BEATTY ROAD
MONROEVILLE, PENNSYLVANIA 15146
APRIL 1979

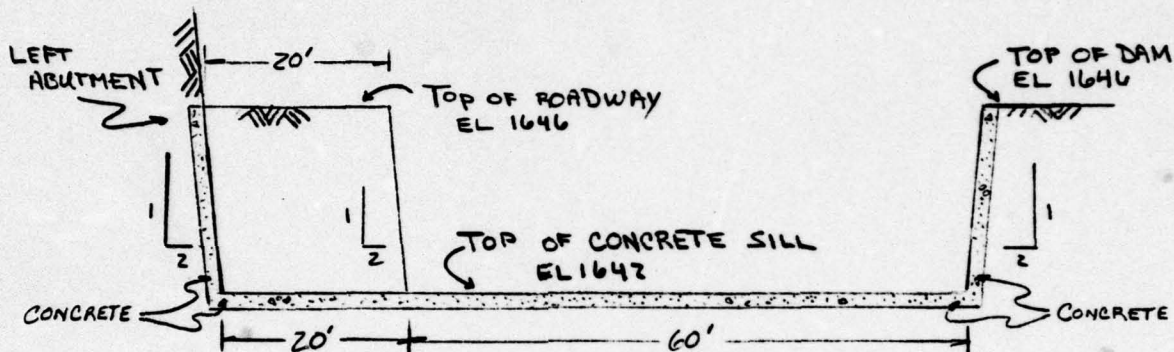
EMERGENCY SPILLWAY CAPACITY

CROSS-SECTION AT CONTROL

SPILLWAY PROFILE (NOT TO SCALE)

NOTE 4: THE ABOVE DRAWINGS WERE SKETCHED BASED ON MEASUREMENTS TAKEN DURING THE FIELD INSPECTION
